Report on the Effects of the January 2011 Flood on the Mangrove Communities Along the Brisbane River

January 2012

Prepared by: Biodiversity and Ecosystem Sciences, Department of Environment and Resource Management

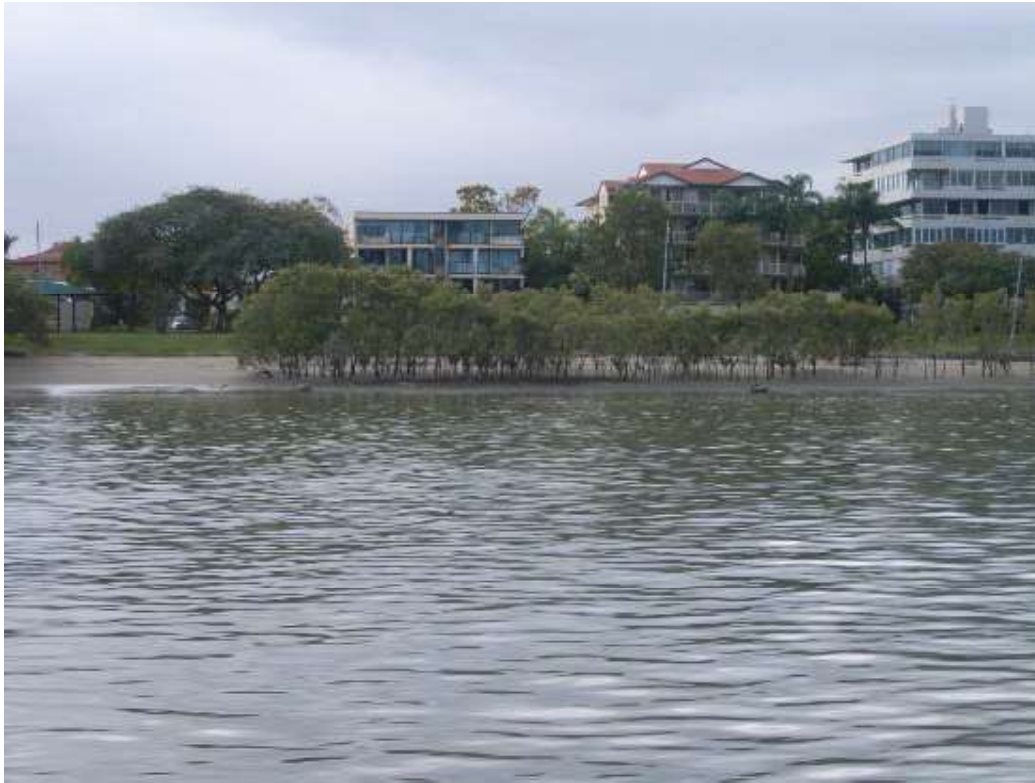
There are limited occurrences of mangroves along this section of the river and as a result the damage to the mangrove communities is minimal. In the main, sand has been deposited around the root systems of grey mangrove communities over the existing silt deposits in this section. The deposition of sand is not expected to have any impact on the existing mangroves as sands tend to be well aerated (see Photograph 1 Appendix A). Sands were also being deposited in these areas prior to the flood; however the flood has resulted in substantially greater quantities of sand being deposited in these areas.

Photograph 1 Sandy deposits around mangroves, New Farm.

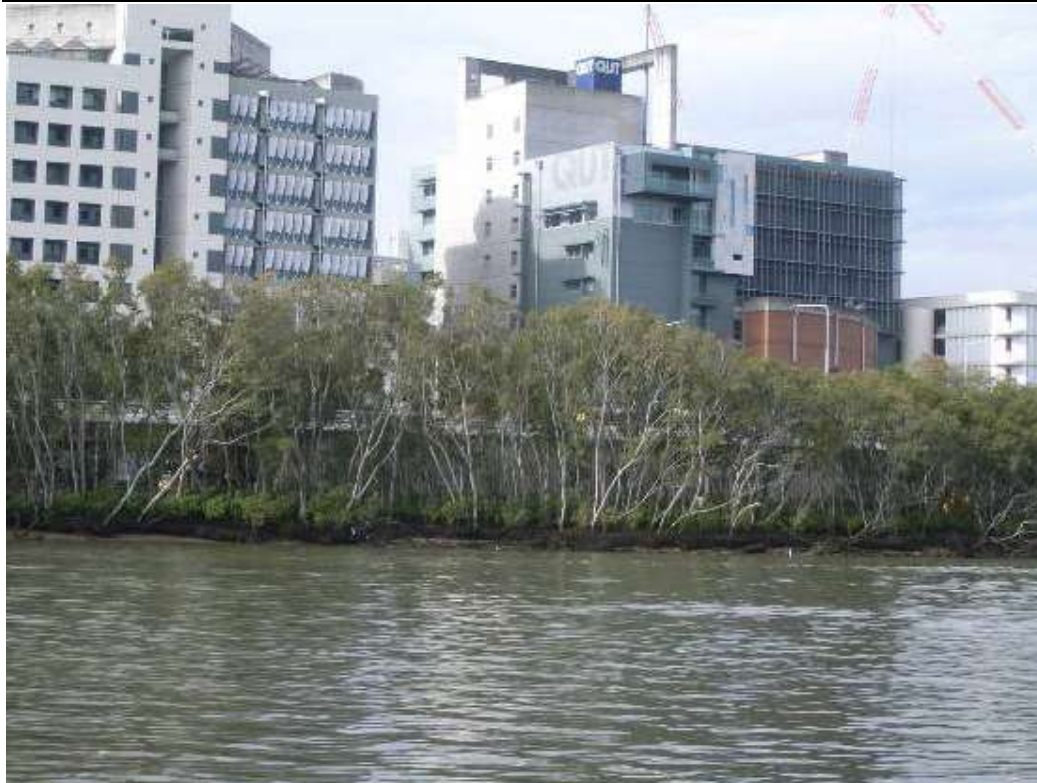
The area of mangroves downstream of the QUT CityCat Terminal to the Goodwill Bridge adjacent to QUT prior to the flood was subject to erosion with the outside fringe of the mangroves falling into the river. The flood resulted in the removal of those trees that had fallen into the river and scouring of the outside edge of the mangroves in this area (Photograph 2). In February 2011 this area had a relatively shallow layer of silt deposited over its surface. In June 2011 this section of river was more or less in the same condition as at February 2011.

Photograph 2 Eroded mangroves adjacent to QUT and Riverside Expressway, South Brisbane Reach.

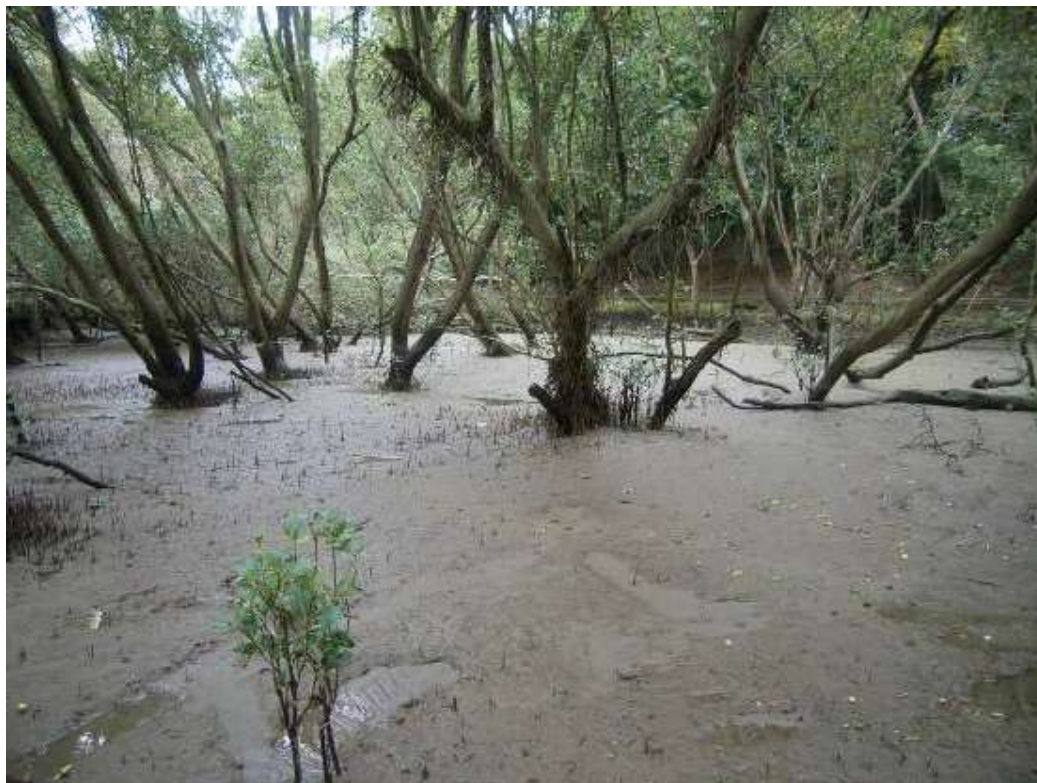
At Gardens Point the flood resulted in the deposition of a large amount of silt and mud which in parts formed mounds up to 1.5 m in height. By June 2011 these mounds of silt and mud had smoothed out so that most of the area at Gardens Point was covered by a thick layer of mud (Photograph 3). It can be expected that the grey mangroves within this area will continue to die for some time into the future unless normal hydrological processes continue to remove this thick layer of silt.

Photograph 3 Silt deposition Gardens Point June 2011.

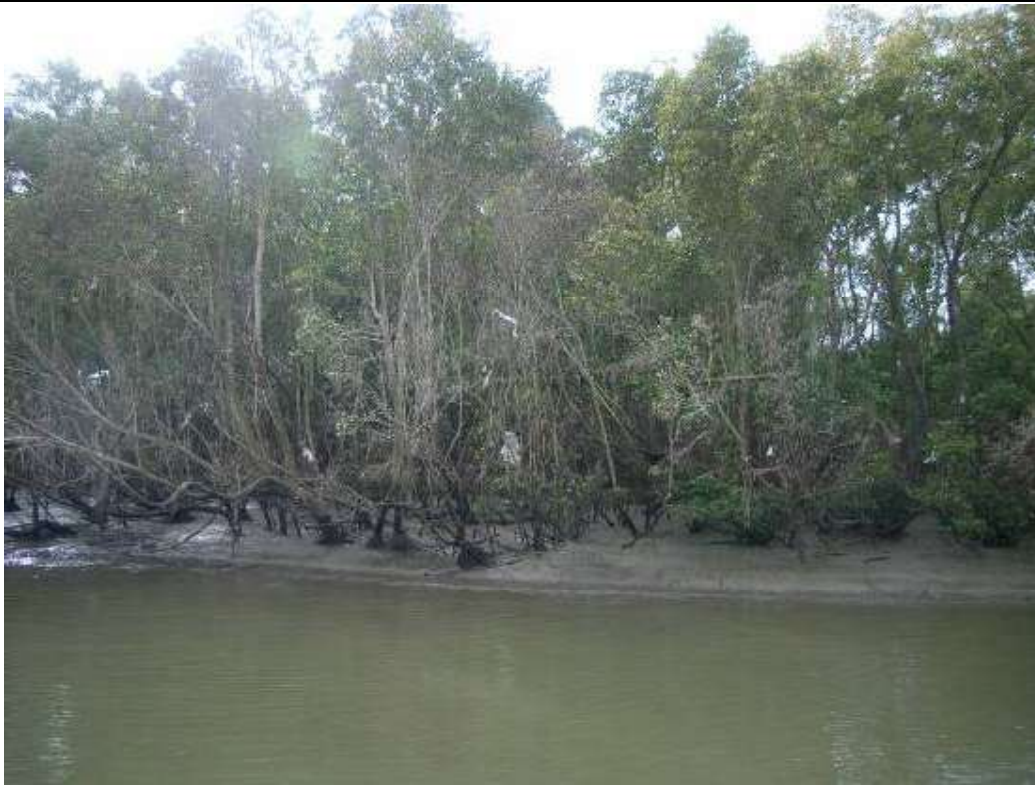
Along the northern bank of the river upstream of the Eleanor Schonell Bridge adjacent to the University of Queensland there was an extensive stand of mangroves. The water's edge of much of this stand was eroded and had collapsed into the river in February 2011. The remaining area was a mixture of living and dead trees with the living trees being on the landward edge of the mangroves (Photograph 4). A thick deposit of silt covered much of the area so that the mangroves in this area are likely to decline over time.

Photograph 4 Dead and living mangroves northern bank of the river upstream of the Eleanor Schonell Bridge adjacent to the University of Queensland with the roots of grey mangrove covered by a thick layer of silt.

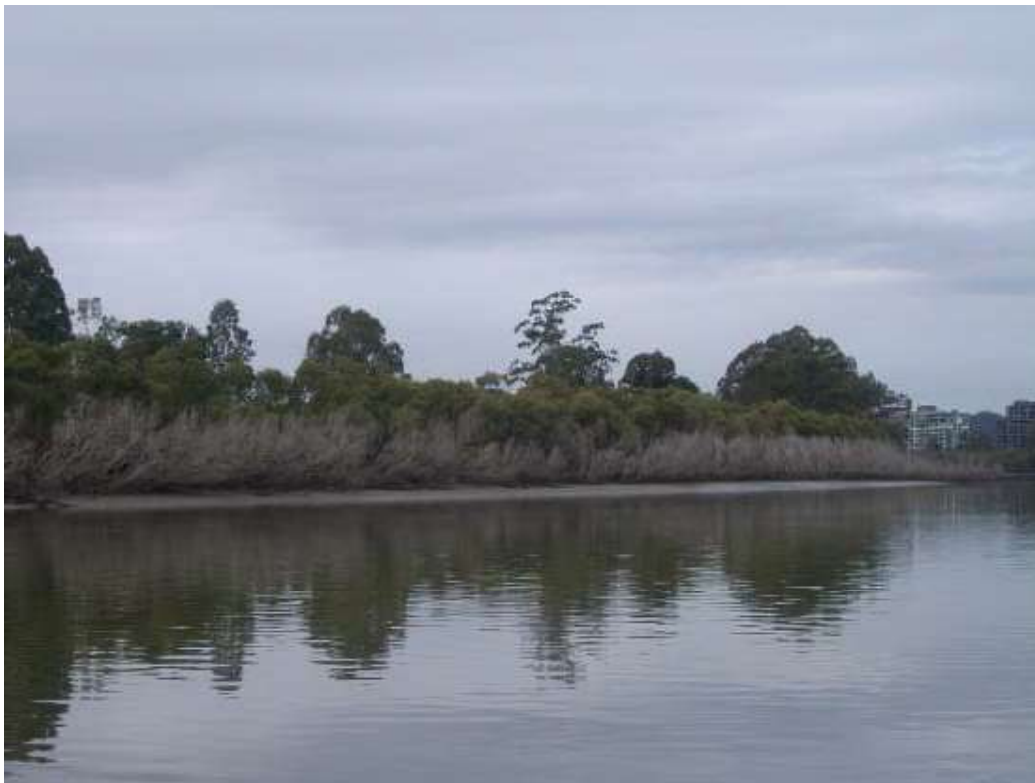
The substantial area of mangroves at Indooroopilly Island was intact at the time of the visits however there were some sections that have had their outside edge removed by erosion. In areas upstream of Indooroopilly Island there was extensive death of mangroves on the water's edge. Most of these mangroves had a downstream lean having been forced over by the strength of the flows (Photograph 5). This phenomenon was also evident elsewhere in many areas upstream from Indooroopilly Island such as Mermaid Reach at Jindalee.

Photograph 5 Dead mangroves adjacent to Indooroopilly Island.

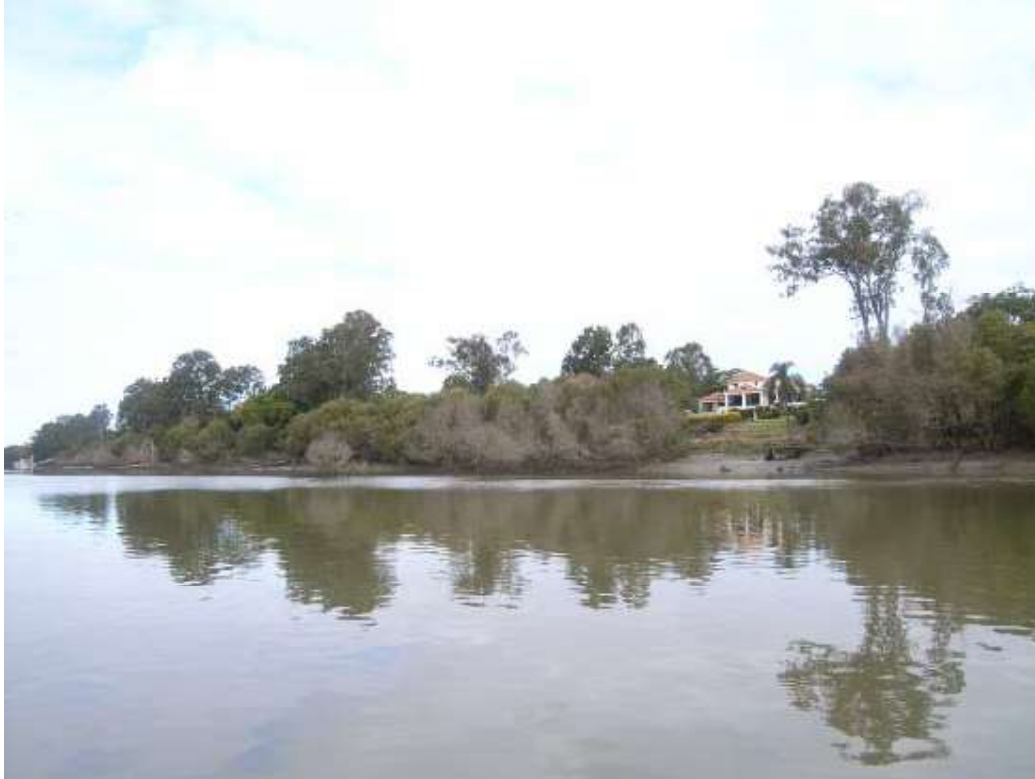
Along the southern bank of Indooroopilly Reach from Tennyson to the Walter Taylor Bridge the mangroves were mainly a mixture of dead and living plants with a thick layer of silt on the surface (Photograph 6). The visit in June 2011 revealed that the mangroves over much of this area were dead or dying and the extent of death of the mangroves was much more extensive than in February 2011. The area around the Queensland Tennis Centre at Tennyson which consisted of large old trees of grey mangrove had a much more extensive area of death in June than was present in February 2011 (Photograph 7). This area also had a very deep layer of silt deposition on the surface. It can be expected that the mangroves within this area will continue to die.

Photograph 6 Dead and living mangroves Indooroopilly Reach, Chelmer.

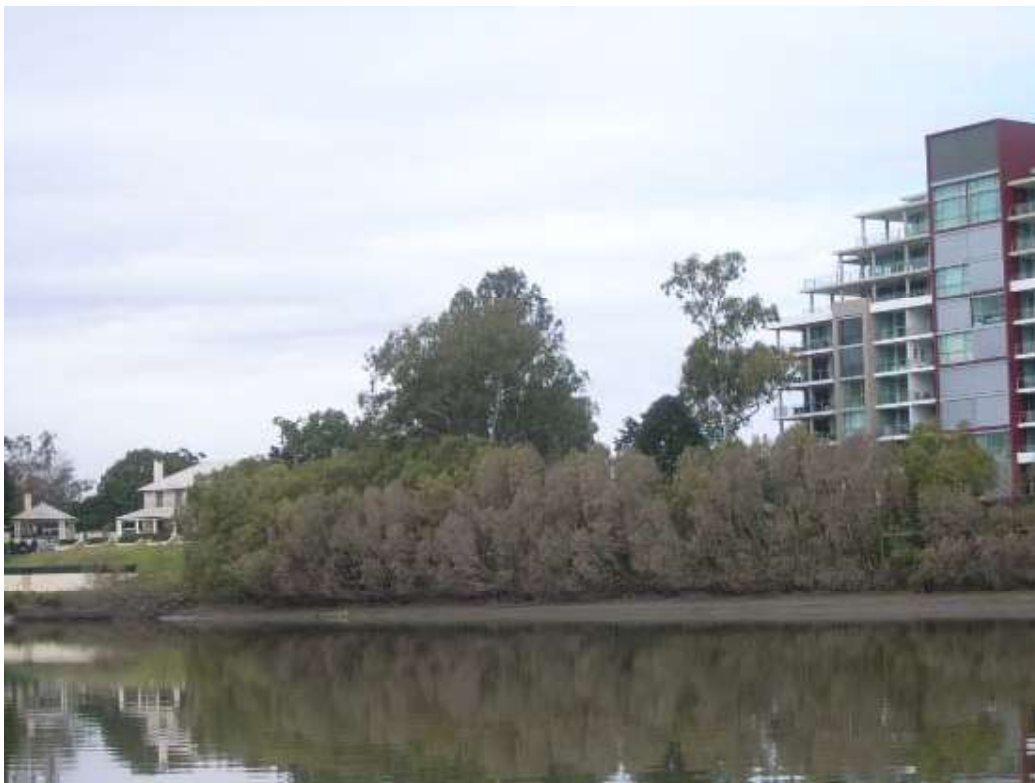
Photograph 7 Dying grey mangroves June 2011 adjacent to Queensland Tennis Centre at Tennyson.

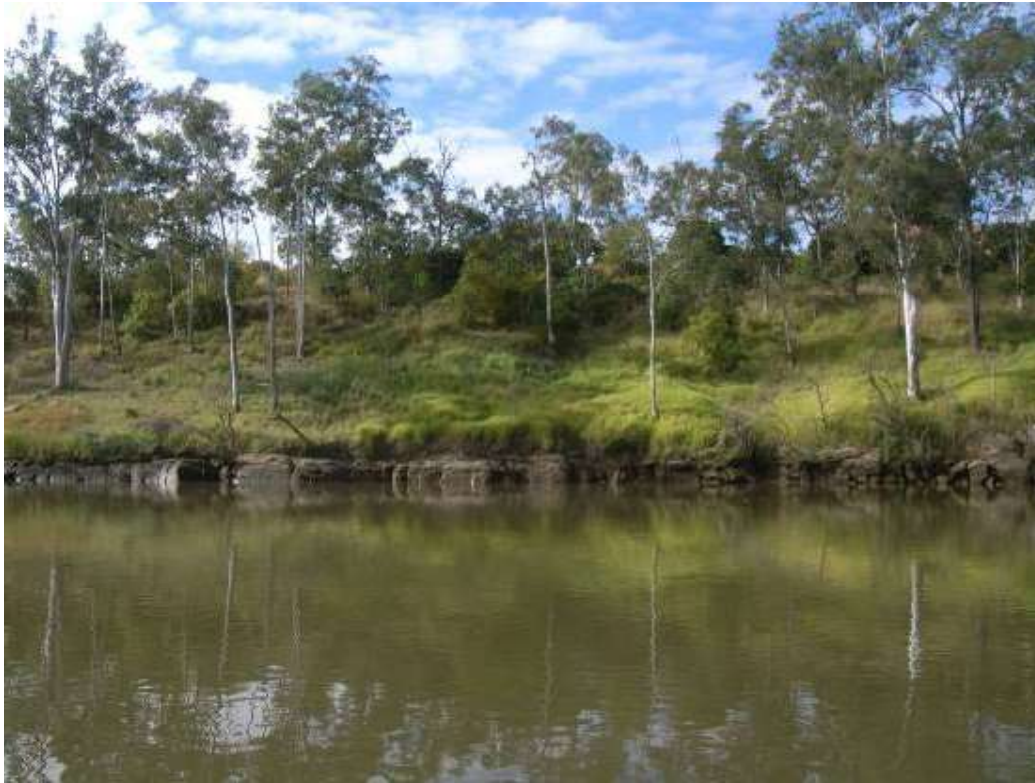
Photograph 8 Scouring was most severe in areas in which there had been relatively little mud deposit over the years and where mangroves were growing on the base rocks forming the edge of the river.

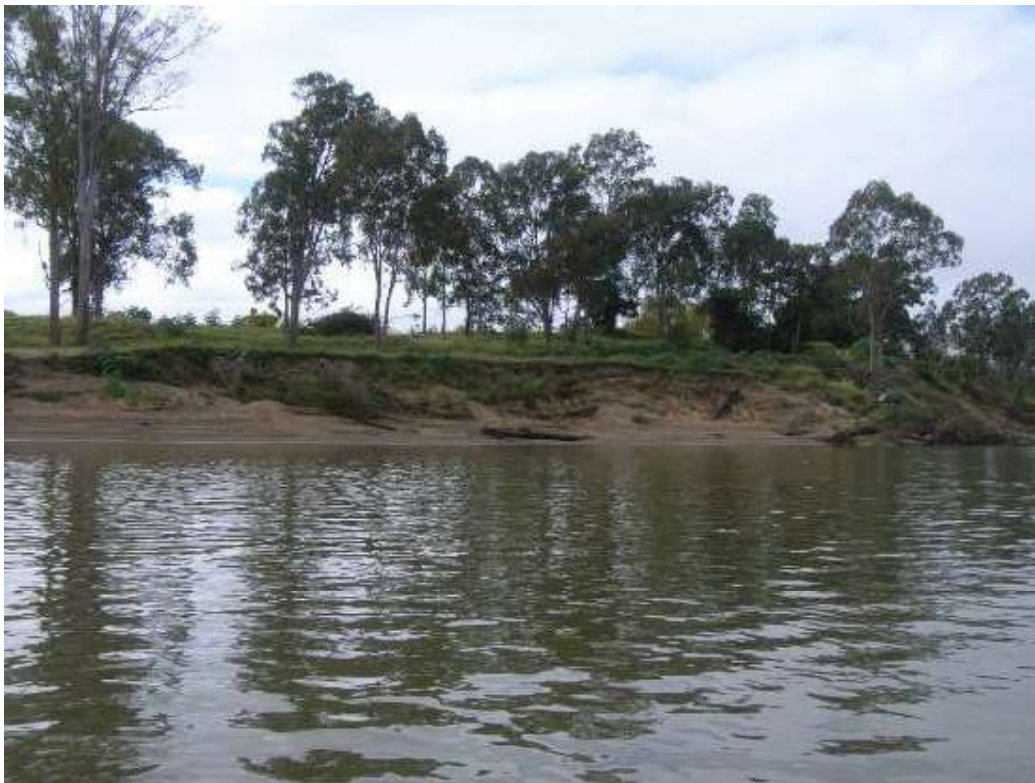
Photograph 9 Eroded River Bank, Fig Tree Pocket.

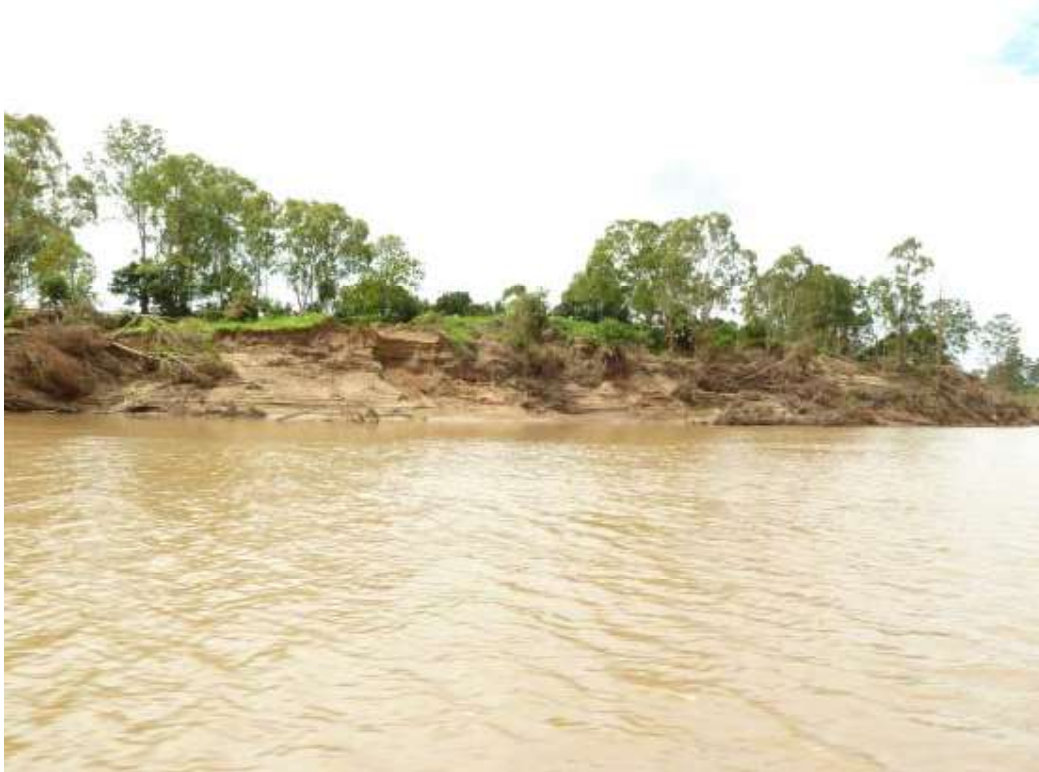
Photograph 10 River bank erosion at Moggill opposite Six Mile Creek.

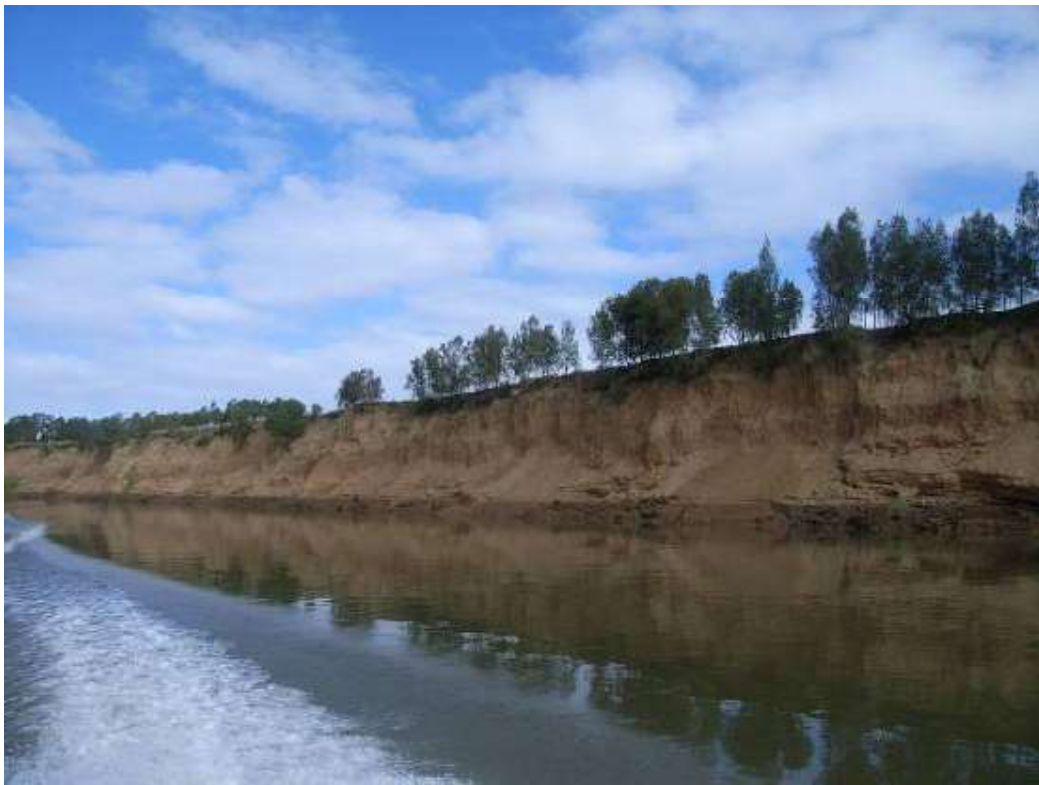
Photograph 11 Severe erosion of river bank Moggill, adjacent to Avonmore St.

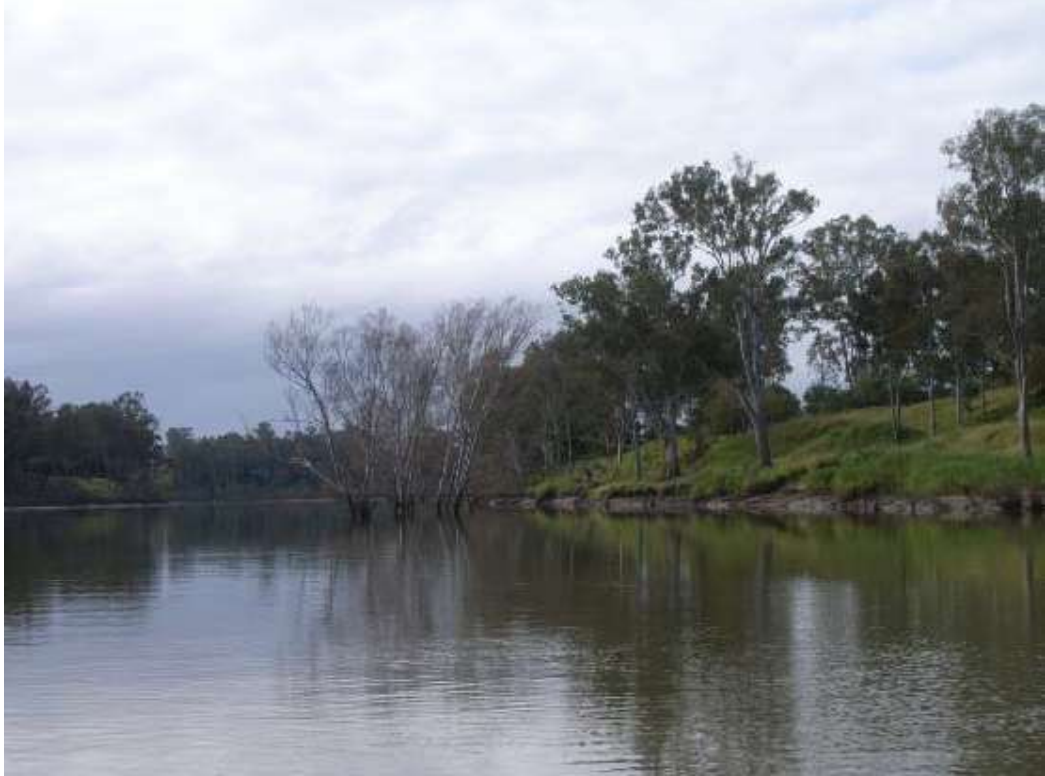
Photograph 12 Slumping of river bank at Wacol.

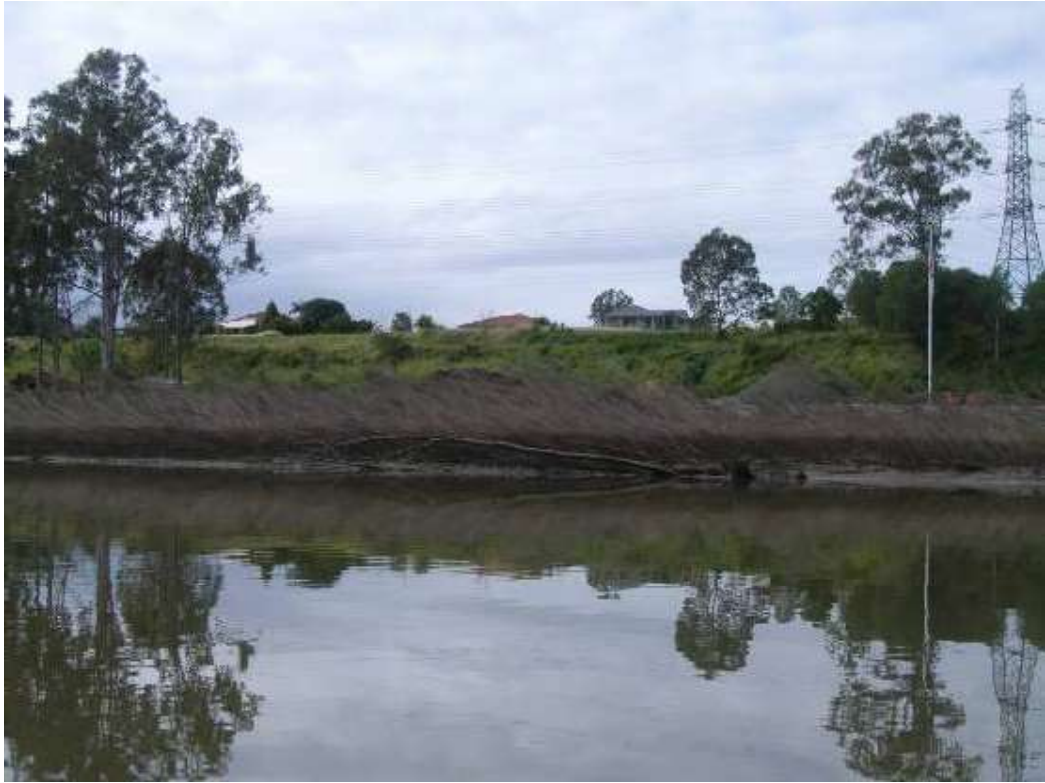
Photograph 13 Dead grey mangrove at Riverhills near rowing club.

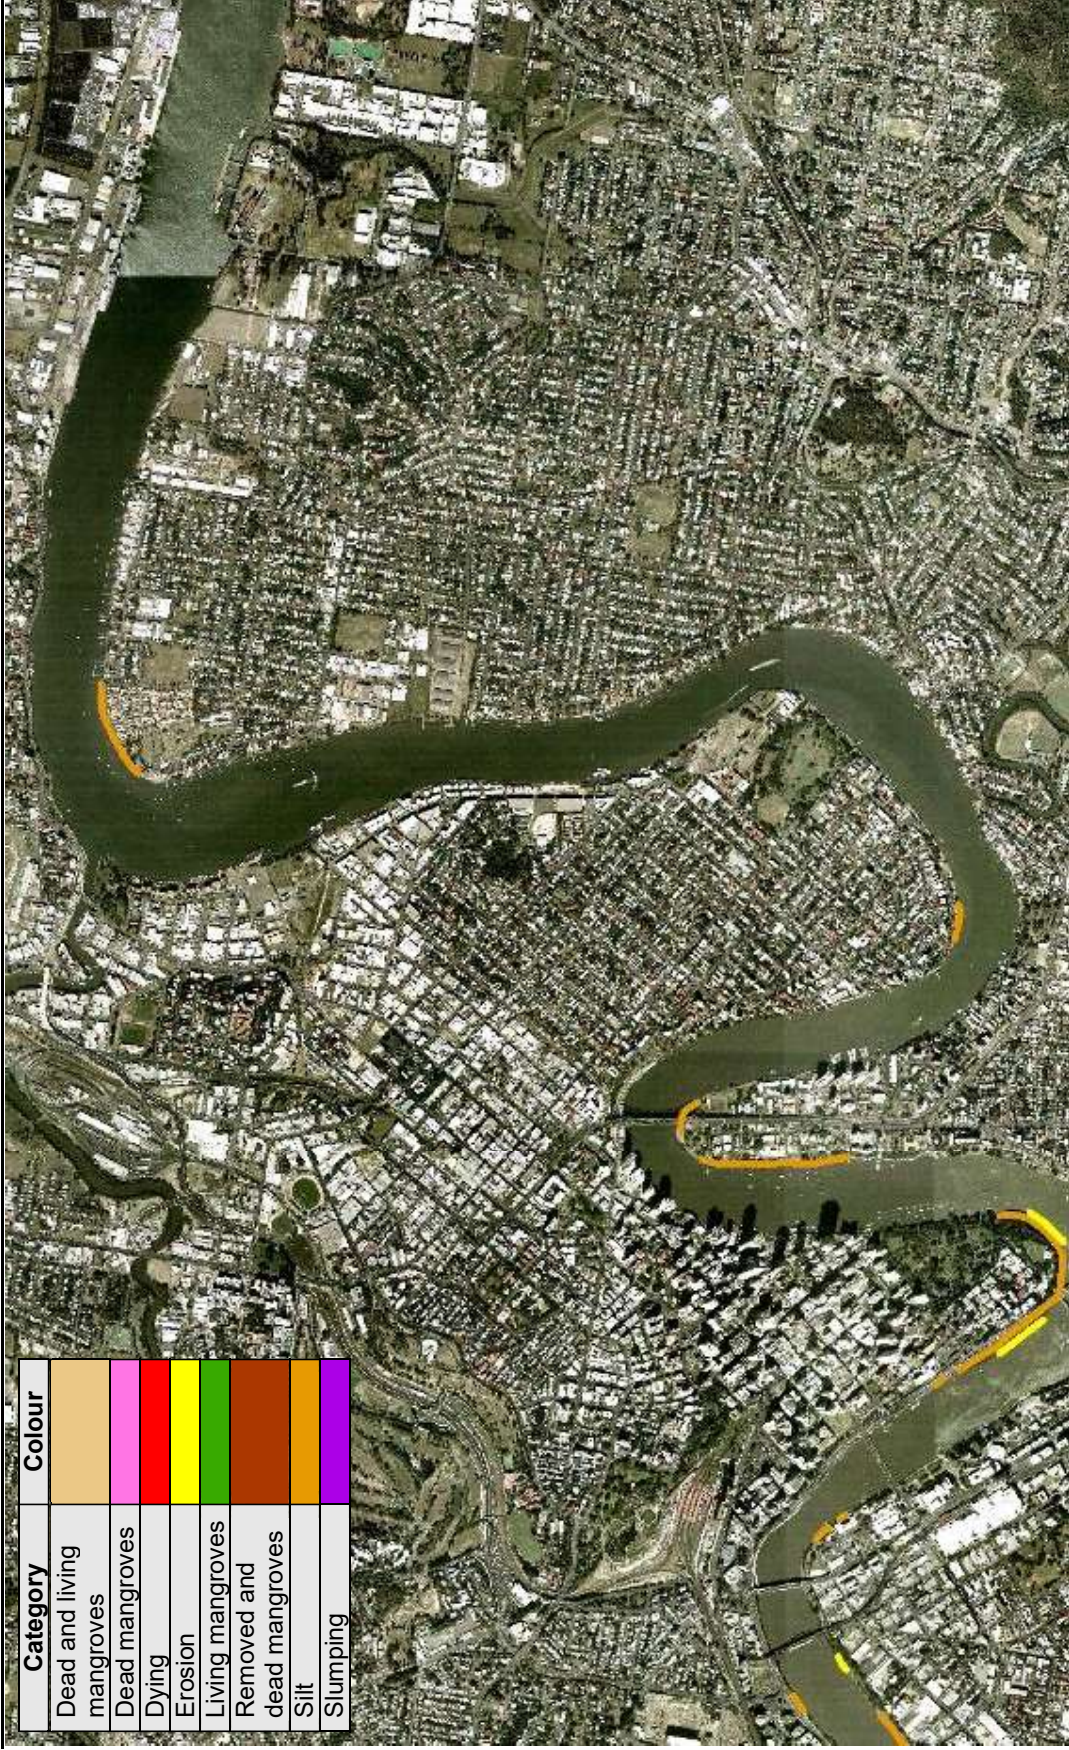
Aerial photograph 3 Breakfast Creek to Story Bridge showing silting, erosion and slumping February 2011.

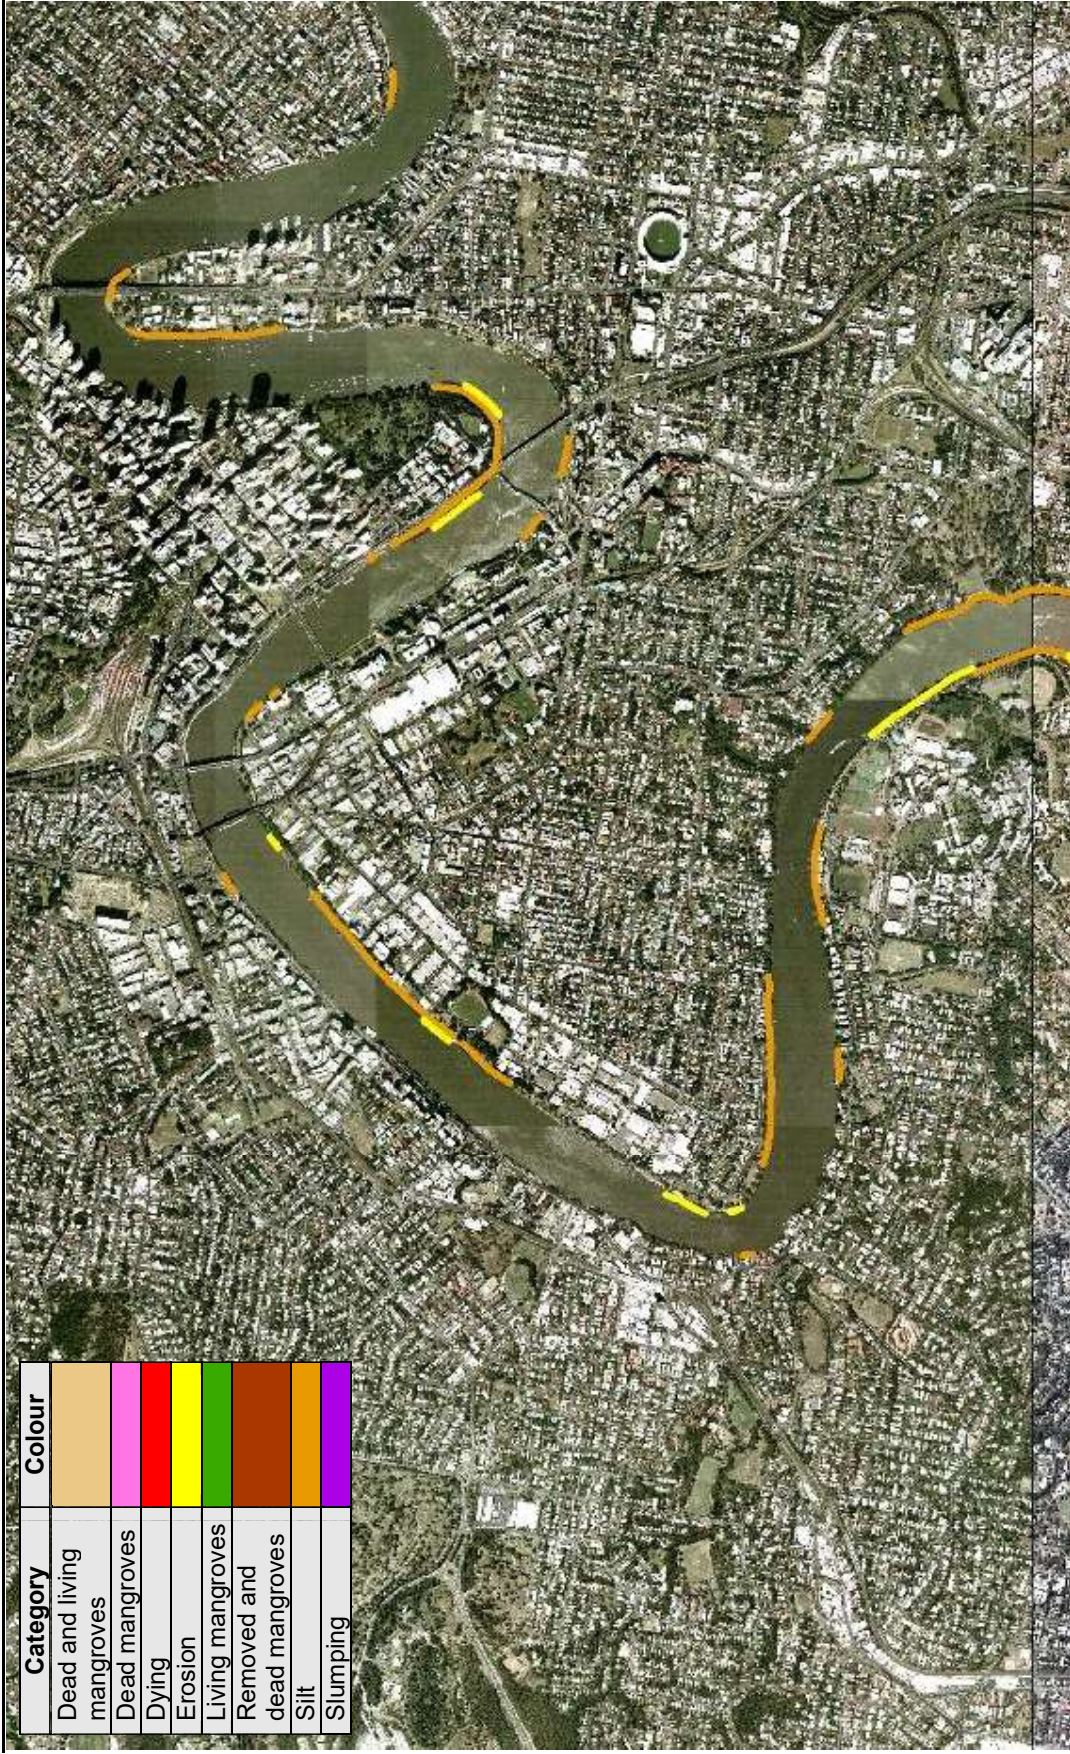
Aerial photograph 6 Story Bridge to St Lucia February 2011 showing silting, erosion and slumping February 2011.

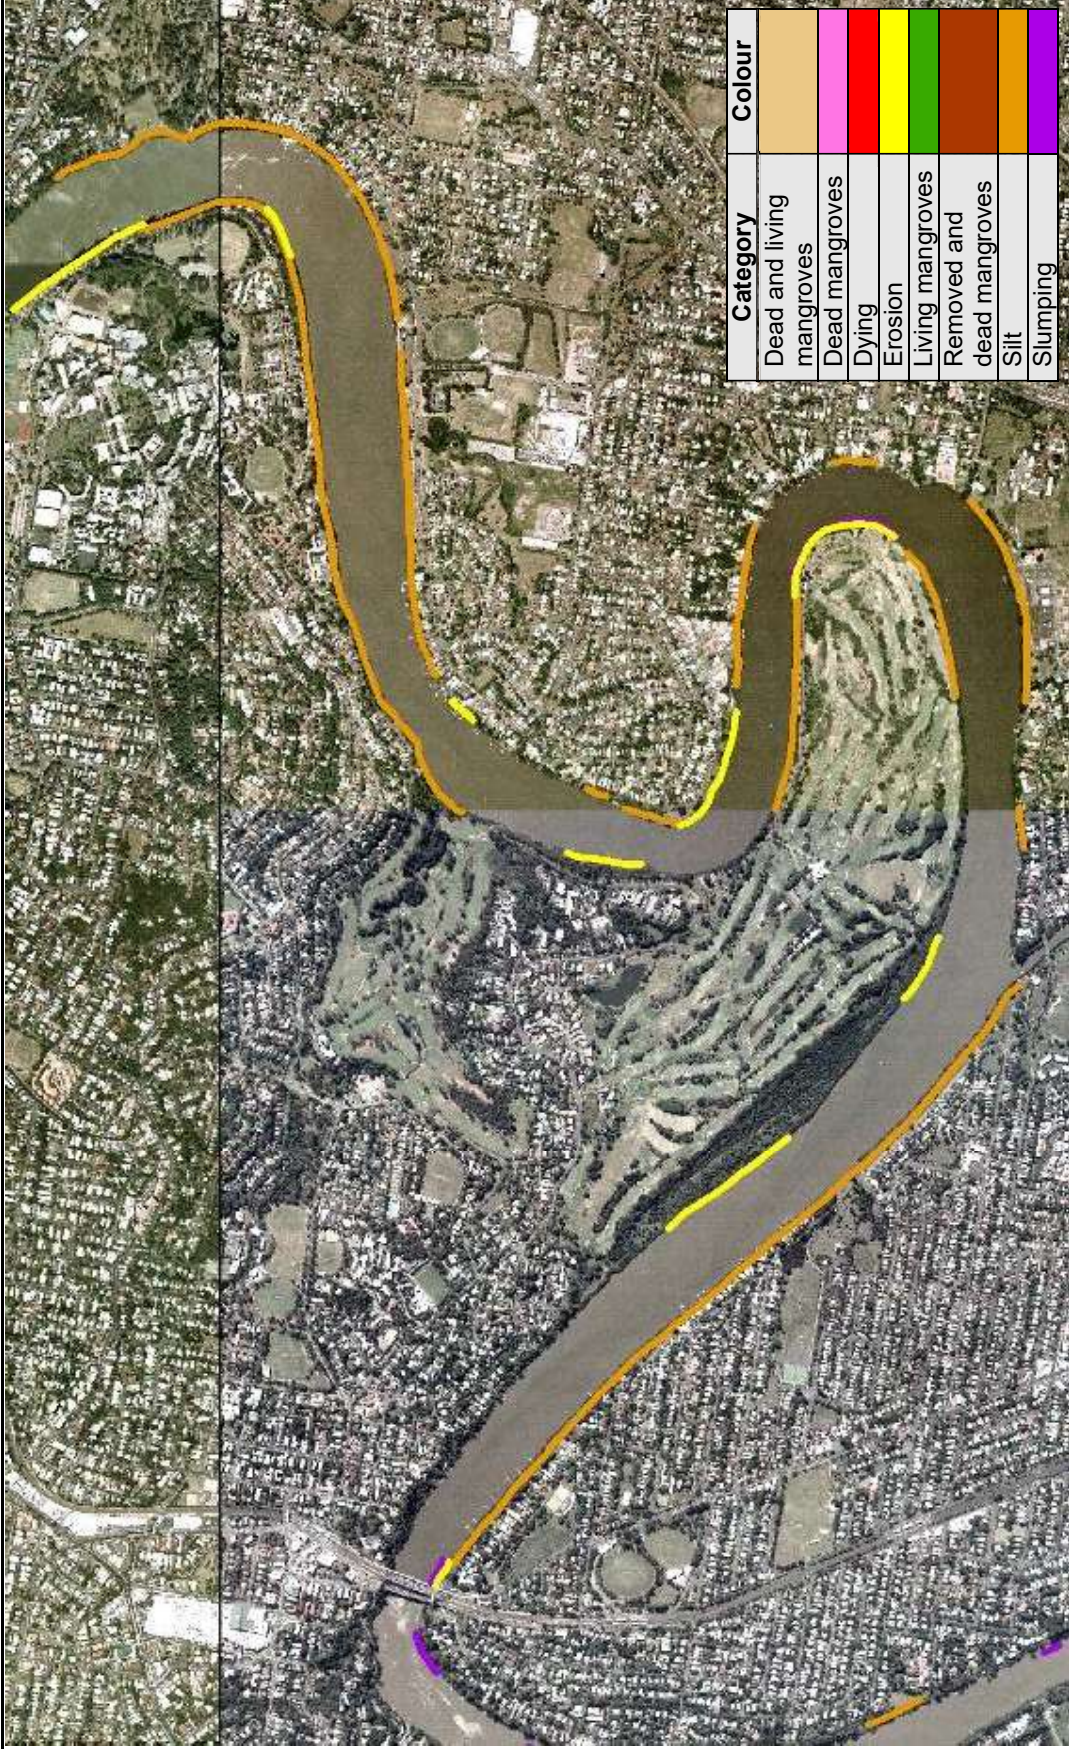
Aerial photograph 9 St Lucia to Walter Taylor Bridge, Indooroopilly showing silting, erosion and slumping February 2011.

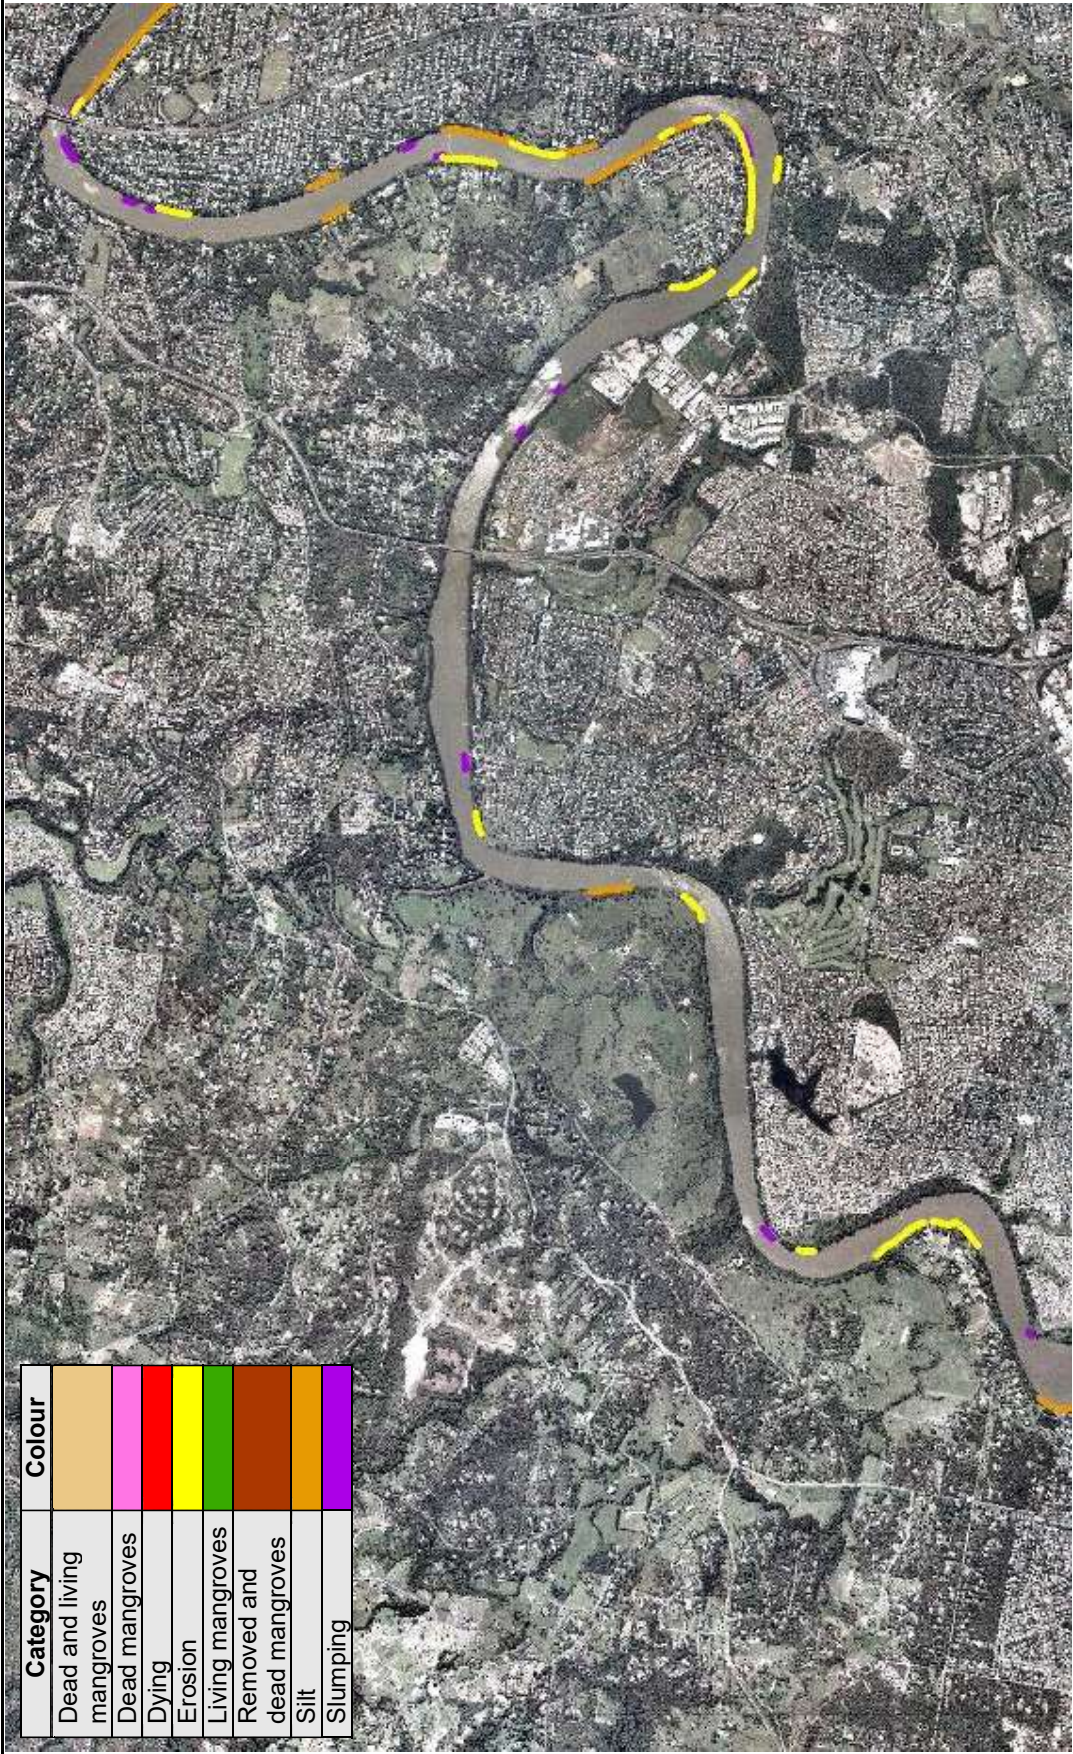
Aerial photograph 12 Walter Taylor Bridge, Indooroopilly to Westlake showing silting, erosion and slumping February 2011.

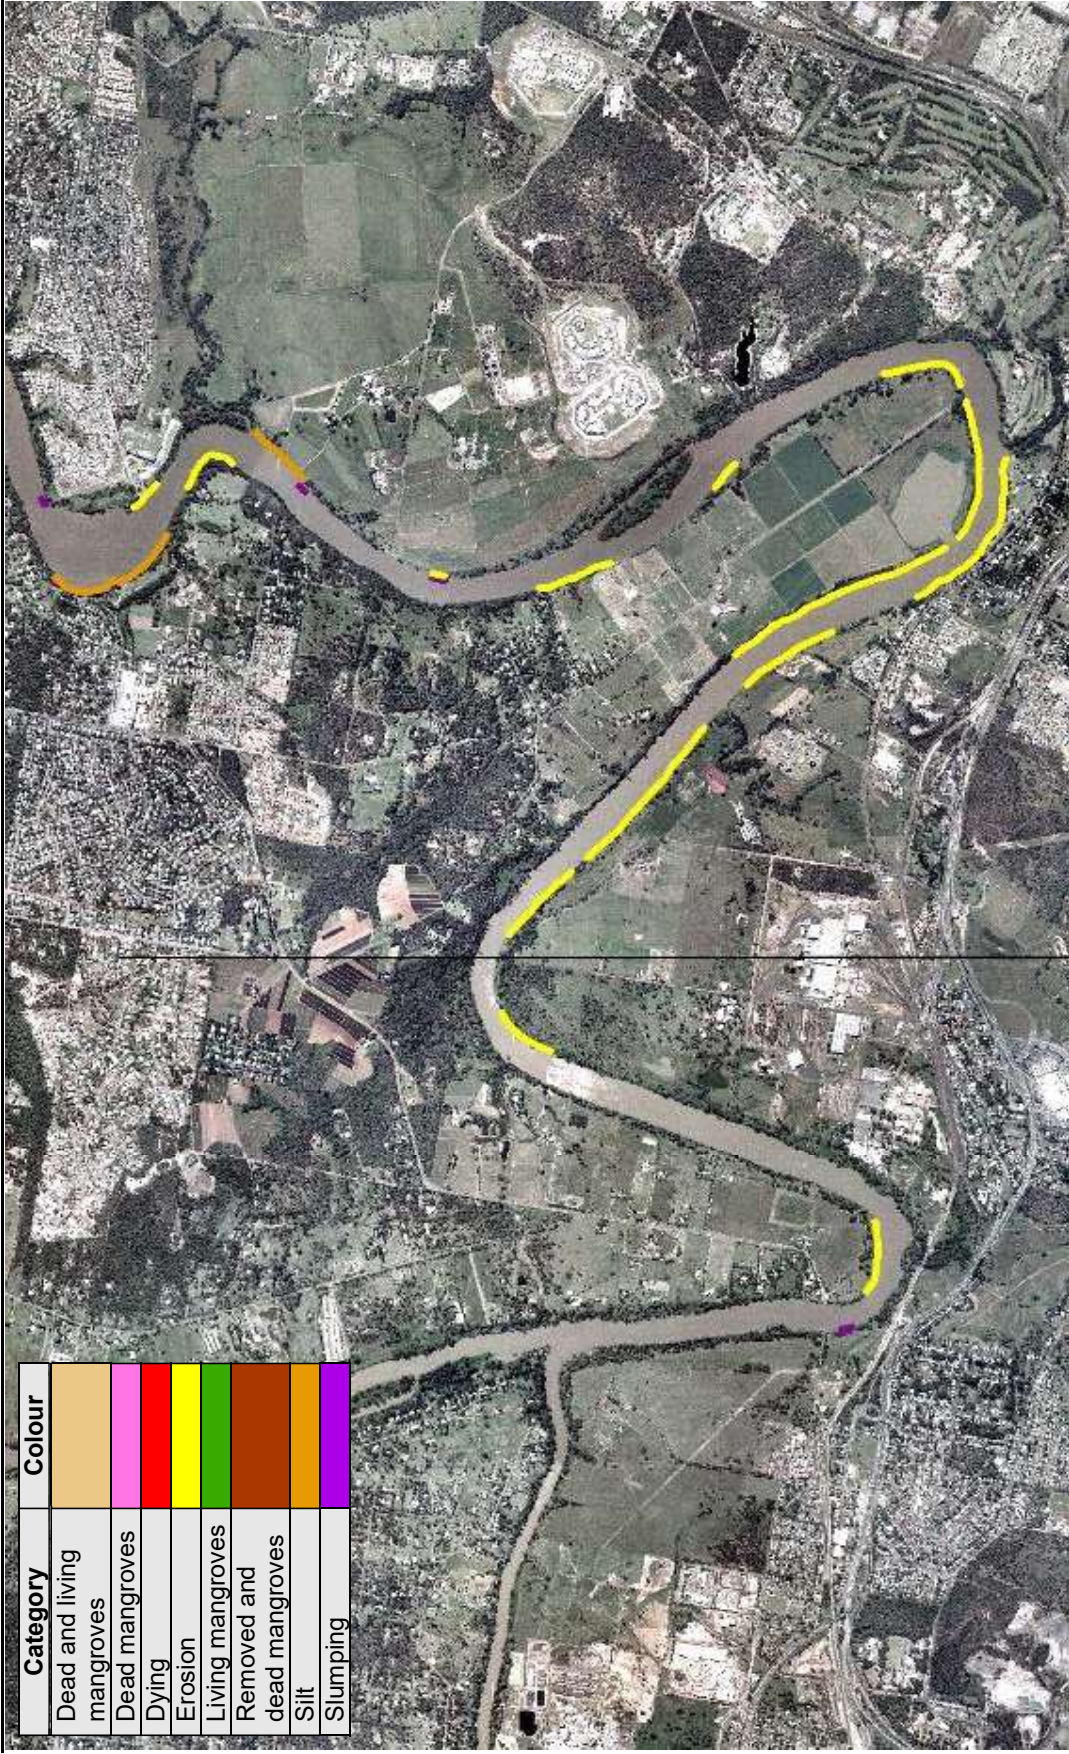
Aerial photograph 15 Westlake to Moggill showing silting, erosion and slumping February 2011.
