Report on the Effects of the January 2011 Flood on the Mangrove Communities Along the Brisbane River

January 2012

Prepared by: Biodiversity and Ecosystem Sciences, Department of Environment and Resource Management

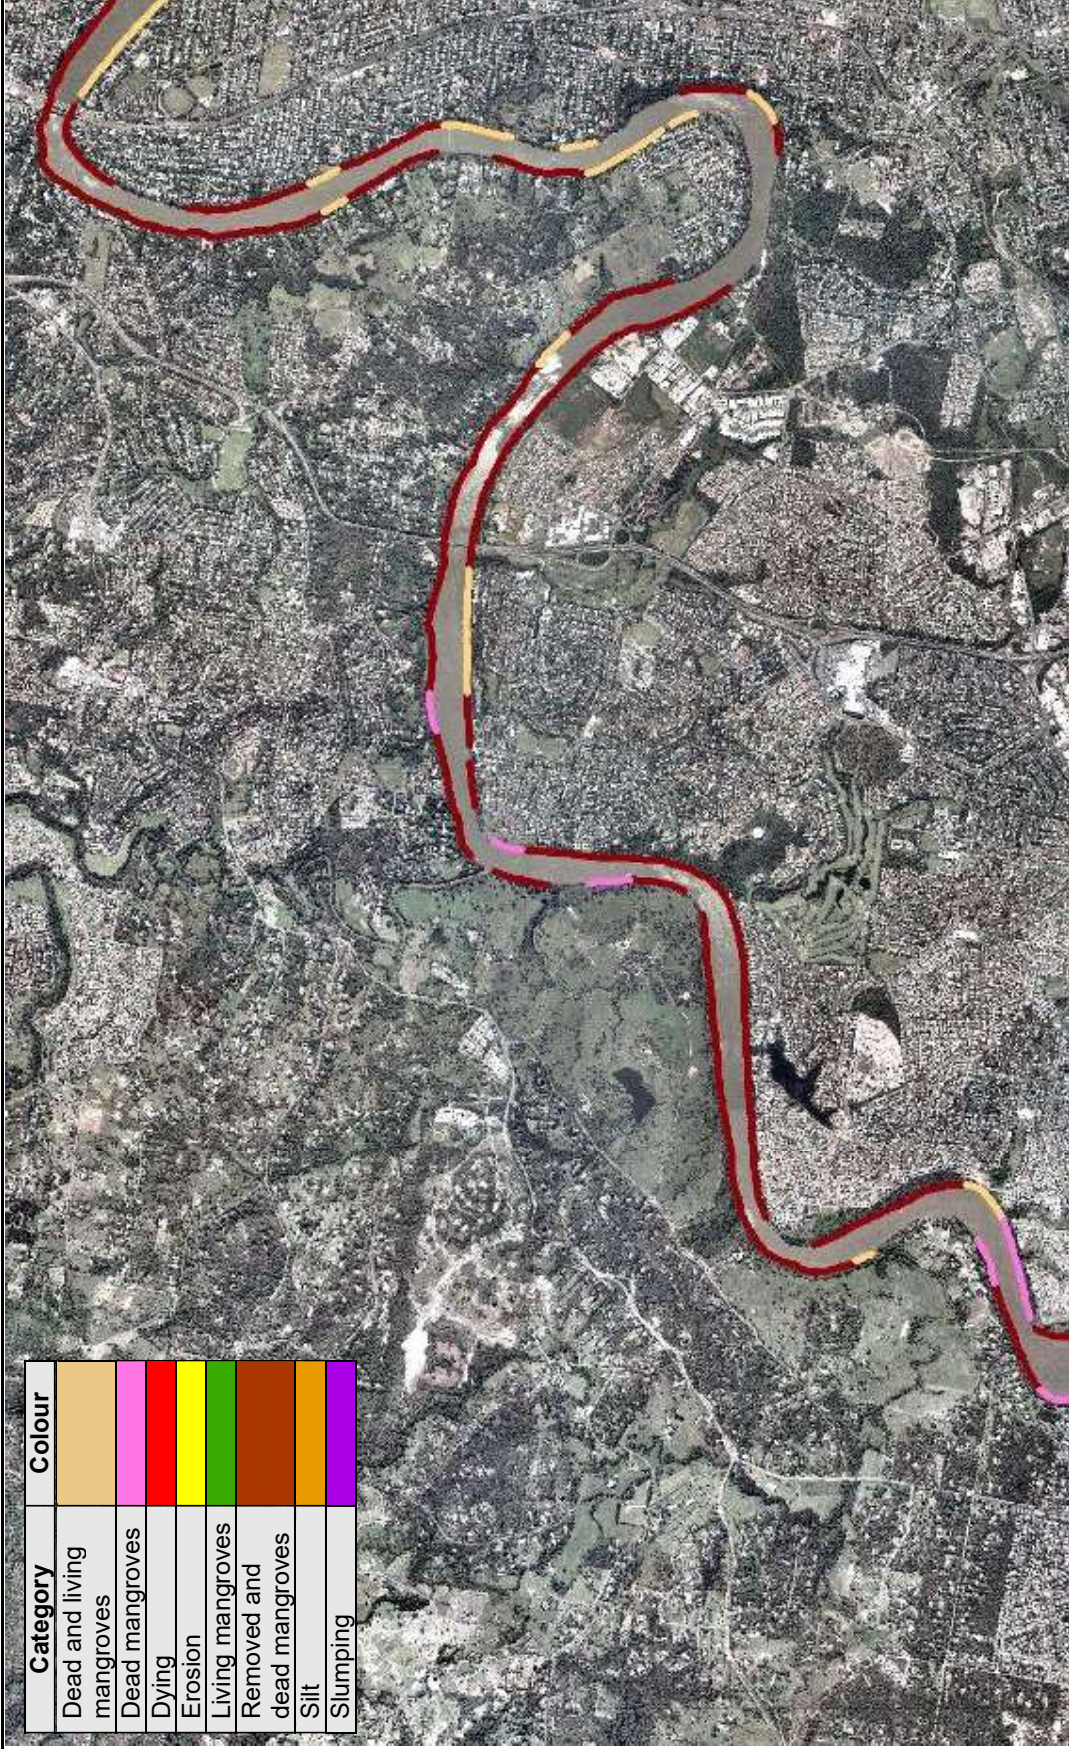
Aerial photograph 10 Walter Taylor Bridge, Indooroopilly to Westlake February 2011.

The most extensive damage of mangroves as a result of the flood occurred in the section of river from the Walter Taylor Bridge, Indooroopilly upstream to the Moggill Ferry. Over most of this area there was a 100 per cent death of mangroves along both banks of the river. For most of this section the mangroves had been either completely killed or they had been scoured from the river banks. Scouring was most severe in areas in which there had been relatively little mud deposition over the years and where mangroves were growing on the base rocks forming the edge of the river (Photograph 8). Along this section of the river is also the area in which the major areas of erosion of the river banks has occurred. This has resulted in areas of relatively minor erosion (Photograph 9, 10) to areas of major erosion such as at Moggill where the erosion is approximately 15 m in height (Photograph 11). Also in this section of the river there were a number of sections of the river that had slumped into the river channel (Photograph 12). From Jindalee to Westlake the mangroves have all been killed but have been left in place along the river bank.
